INTERNATIONAL SYMPOSIUM ON  
**DAMS IN A GLOBAL ENVIRONMENTAL CHALLENGES**  
Bali, Indonesia, June 1<sup>ST</sup> – 6<sup>TH</sup>, 2014

**European Working Group "Management of dam incidents"  
Case study: Finland**

**Mr. Juha Laasonen**

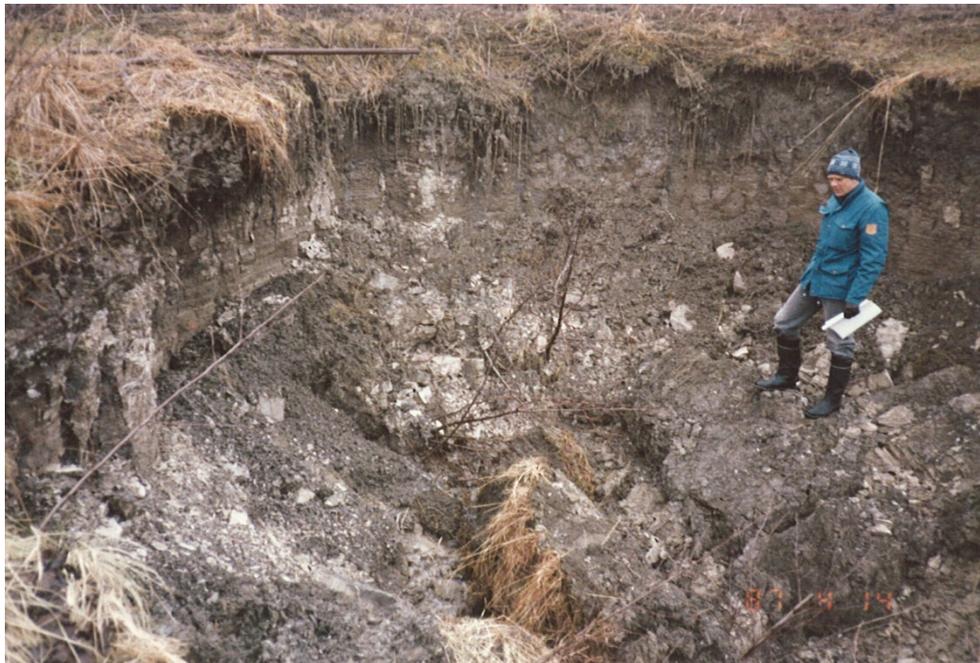
The springs at Peltokoski embankment dam appeared during the first fill of the reservoir in 1950's and second one in 1980's. In late winter 1987 the spring collapsed approx. 60 meters from the left embankment dam. A large sink hole of 3 meter deep and a settlement of 29 cm at the dam crest were formed (**Figure 2**). The collapsed bank was repaired by constructing inverse filter with stones on the surface and with grouting of the embankment. Two Thompson overflow weir were constructed behind the inverse filter. Total leakage was 35 l/s. The water was clear without any sediment suspension. Main reason for the internal erosion was the leakages through the fissured bedrock (Laasonen, 2010).

**Figure 2.** A large sink hole appeared at the place of spring in 1987 (Laasonen, 2010)

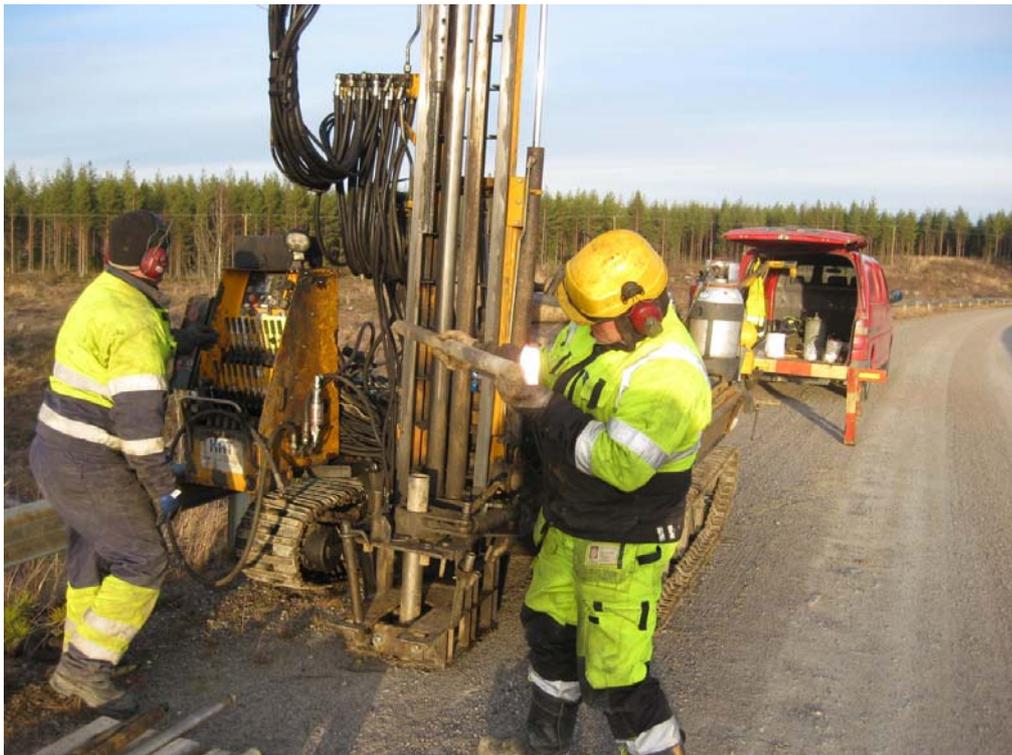
Pamilo embankment dam in the eastern part of Finland has had several dam incidents. first one during the first filling and the latest sink holes appeared in 2008 and 2012. The sink holes were filled and emergency grouting was carried out. Several causes for the internal erosion have been considered improper construction of the core (the frosted moraine core was not removed), the deficiencies of the filter and the leakages through the fissured bedrock.

The emergency grouting were carried out in all the cases. In addition extensive site investigations were started in order to find out the cause of the internal erosion (Figure 3).

**Figure 3.** The site investigations at Pamilo embankment dam.
